## INDUSTRIAL HYGIENE SERVICES REPORT

Palo Pinto County Courthouse  
520 Oak Street  
Palo Pinto, Texas 76484

January 24, 2026

Ensolum Project No. 01B4276001

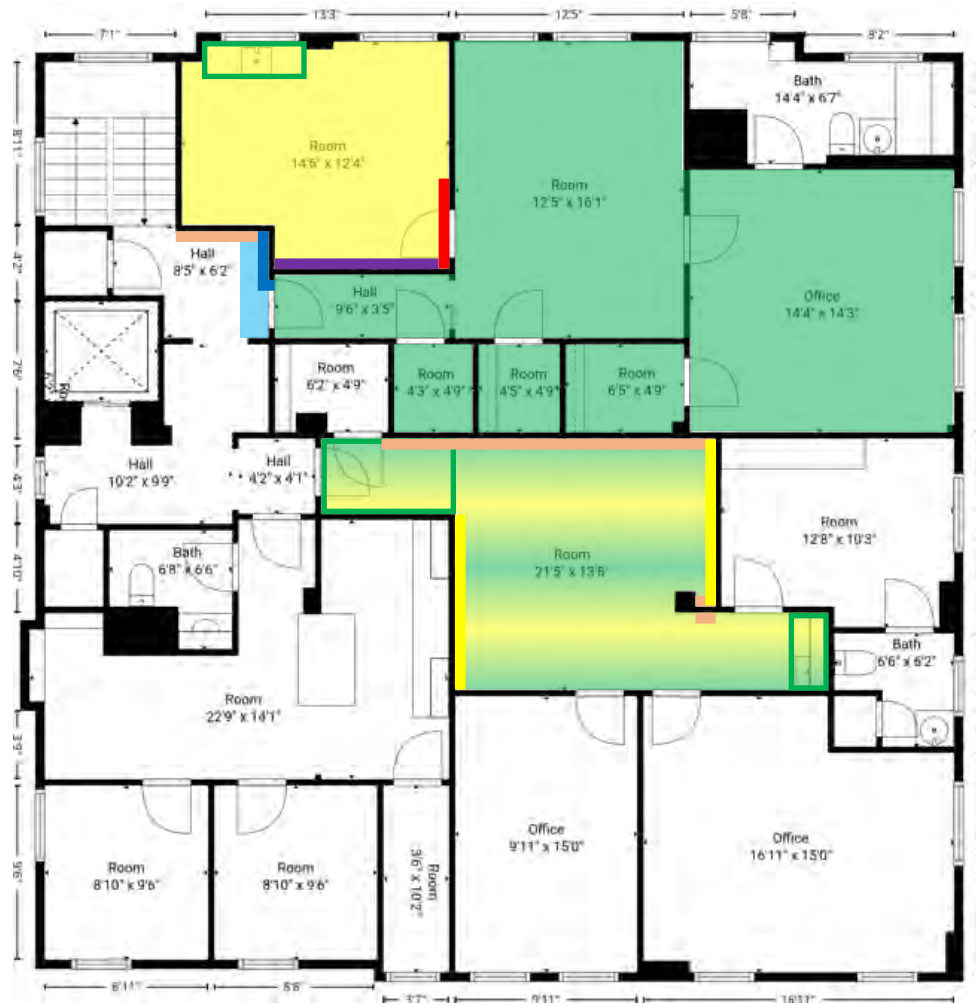
**FIGURE 1: REMEDIATION DIAGRAM –  
Penthouse**

The loss occurred from two separate sources in the Penthouse of the Courthouse, including a domestic water supply line and a water heater. The water released from the two sources in the Penthouse was reportedly discovered on Sunday, November 23, 2025, and the releases were stopped and repaired. Following the releases and prior to discovery, repair, and mitigation, significant water distribution occurred, affecting a substantial portion of the structure beneath the release. At the time of Ensolum's assessment, initial mitigation was complete.

The assessment identified moisture intrusion and affected building materials in the Penthouse and Levels 3, 2, and 1 of the Courthouse. Key observations include:

- e. Non-salvageable porous sheetrock exhibiting elevated moisture levels and/or directly affected by the loss, as documented in Ensolum's Plume and Moisture Diagram (Appendix A), should be removed to prevent mold proliferation and

- structural degradation. Removal should follow IICRC S500 guidelines, with cuts made at least 12 inches above the highest point of visible water damage or as indicated in the Moisture Diagram.
