## INDUSTRIAL HYGIENE SERVICES REPORT

Palo Pinto County Courthouse  
520 Oak Street  
Palo Pinto, Texas 76484

January 24, 2026

Ensolum Project No. 01B4276001

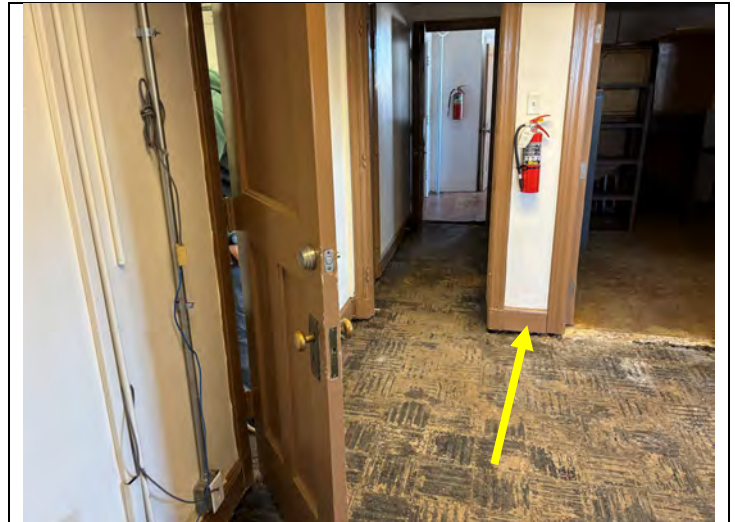
2. View of test #73 location (baseboard) with lead-based paint measured at 7.1 mg/cm<sup>2</sup>.
