## INDUSTRIAL HYGIENE SERVICES REPORT

Palo Pinto County Courthouse  
520 Oak Street  
Palo Pinto, Texas 76484

January 24, 2026

Ensolum Project No. 01B4276001

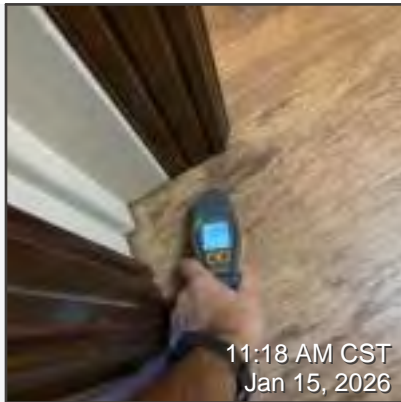
11:18 AM CST  
Jan 15, 2026

### Moisture Assessment

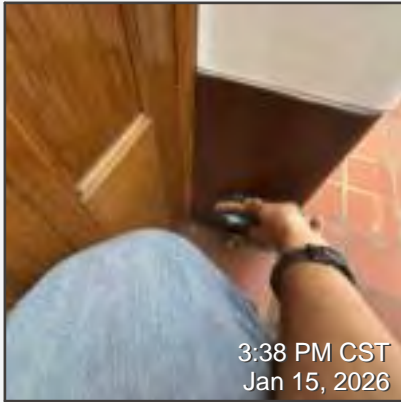
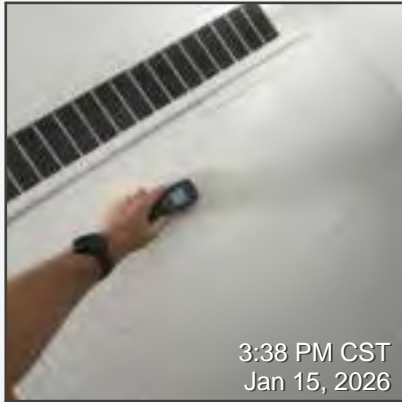
### Room Notes: Level 0.5 - Landing (South)

<p>3:38 PM CST Jan 15, 2026</p>	<p>3:38 PM CST Jan 15, 2026</p>	<p>3:38 PM CST Jan 15, 2026</p>
<p>3:38 PM CST Jan 15, 2026</p>	<p>3:38 PM CST Jan 15, 2026</p>	<p>3:38 PM CST Jan 15, 2026</p>

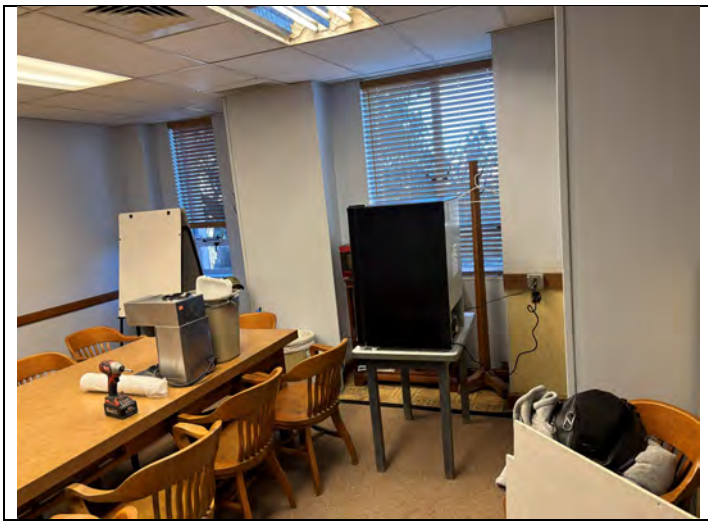
13. View of Jury Room on the 2<sup>nd</sup> Floor.
